COOLING & HEAT PUMP

123 Main Street, Fairfax, VA July 2, 2009

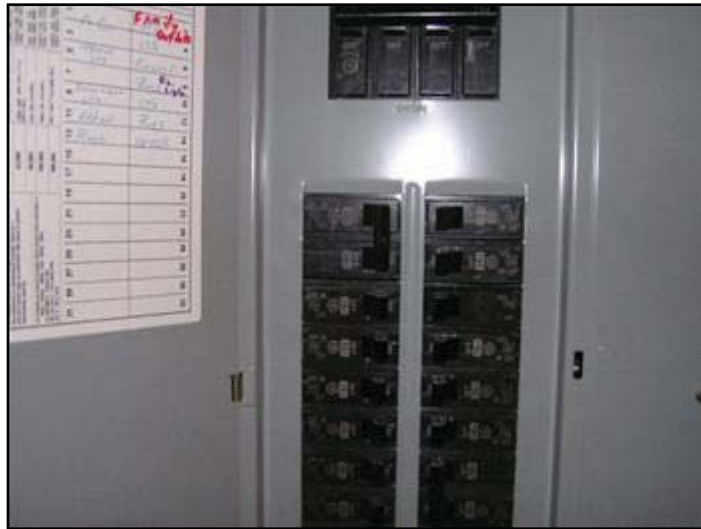
15.

Air conditioning \ Compressor

Condition: • [Wrong fuse or breaker size](#)

Implication(s): Equipment overheating | Damage to equipment | System inoperative or difficult to operate

Location: Rear Exterior

Note: The air conditioner compressor required a maximum size circuit breaker of 30 amps. The compressor was connected to a 50 amp breaker.

Task: Repair
